Debris/Ice/TPS Assessment And Photographic Analysis For Shuttle Mission STS-37

April 1991

Gregory N. Katnik
NASA/Kennedy Space Center

DEBRIS/ICE/TPS ASSESSMENT
AND
PHOTOGRAPHIC ANALYSIS
OF
SHUTTLE MISSION STS-37

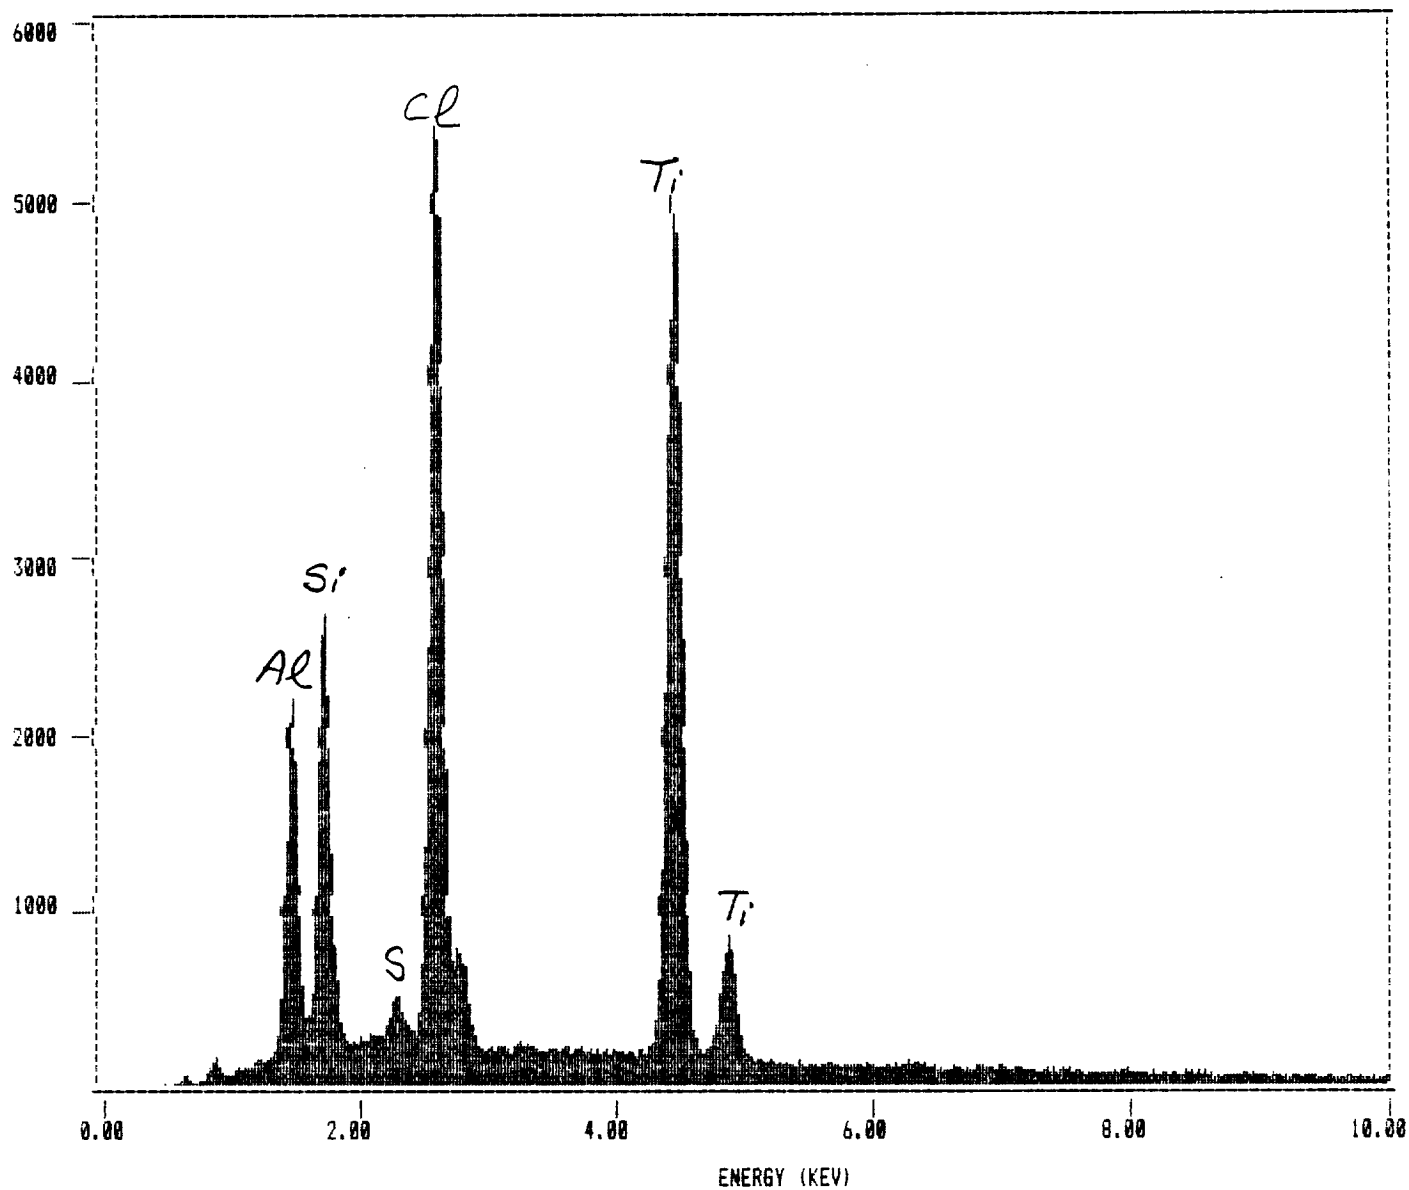
Figure 5 HYP, 2600F, 1HR, 988-90
